Corrosion Control Solution
Case Study: Application on Offshore
Platform for flange protection
Lam Son Joint Operating Company

THANG LONG-DONG DO FIELD, VIETNAM

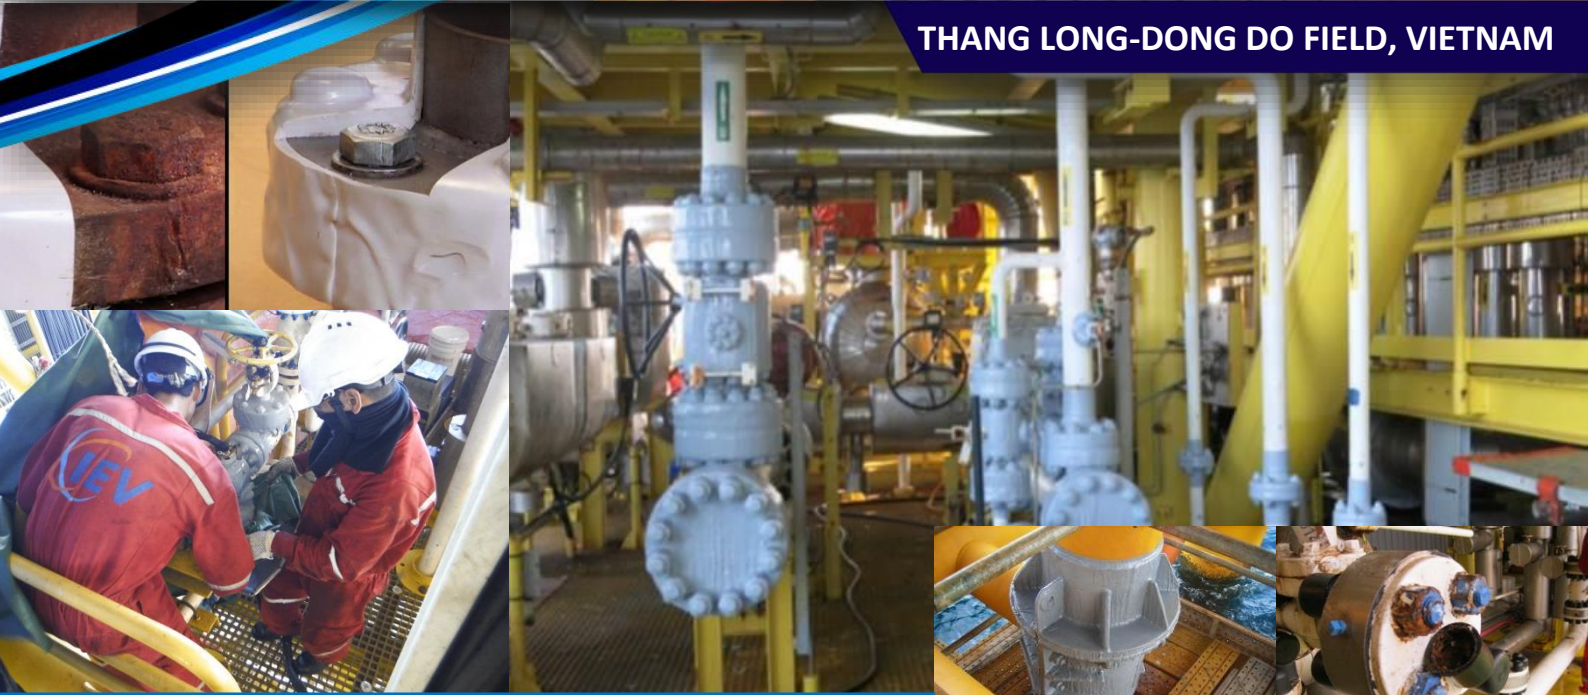
The Oxifree Corrosion Prevention System - Oxifree TM198 coating was the recommended solution to address the conditions on both the platforms. All flanged connections on both platforms were encapsulated in Oxifree TM198 to protect the flange faces and bolts. Oxifree allows full movement of the stems while still providing maximum protection against contamination and corrosion. The solution is proven to significantly reduce maintenance costs and prolong the life of the metal components. It will also be a long term solution for the client in reducing offshore maintenance requirements.

Prior to coating, a minimum surface preparation was done which included cleaning of the bolts, nuts and flanges' surfaces from grease, loose/flaky rusts and moisture before Oxifree TM198 was applied. This is to isolate the atmospheric environment to prevent further ingress of water and/or oxygen and to ensure maximum productivity per day.

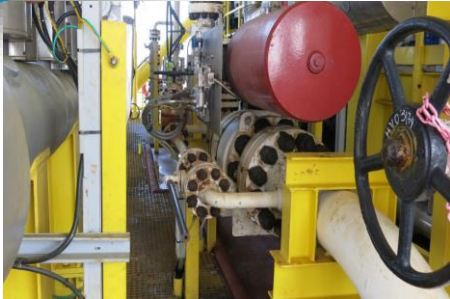
Thang Long Platform: Pig Launcher before cleaning

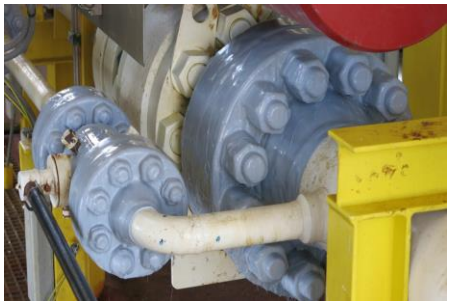
Thang Long Platform: Pig Launcher after cleaning and coating

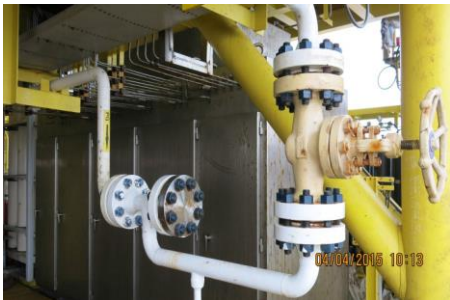
Dong Do Platform: Gas Line after cleaning

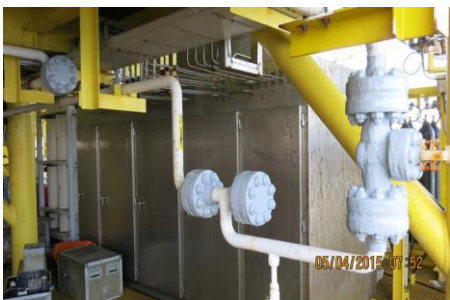
Dong Do Platform: Gas Line after coating
