Pipeline Failure due to Soil Instability A Global Overview, Case Study, and Advanced Monitoring Technologies

**Prepared for Industry Review
July 2025**

**Authored by:
Christopher Do (CTO – IEV) and Dr. E.S. Lim (CBS – Aerodyne)**

5.0 Case Study: Putra Heights Gas Pipeline Explosion (Malaysia, 2025)

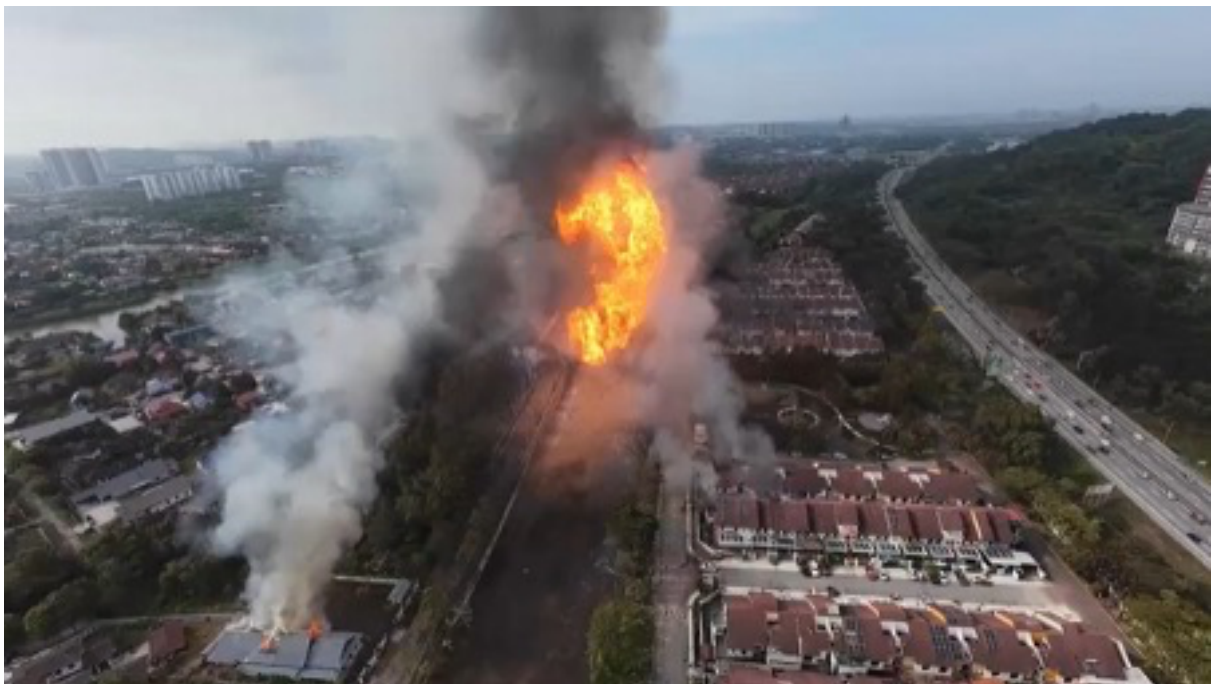
Source: Drone footage from Selangor Fire and Rescue Department / Media coverage of the Putra Heights gas pipeline explosion (April 1, 2025)

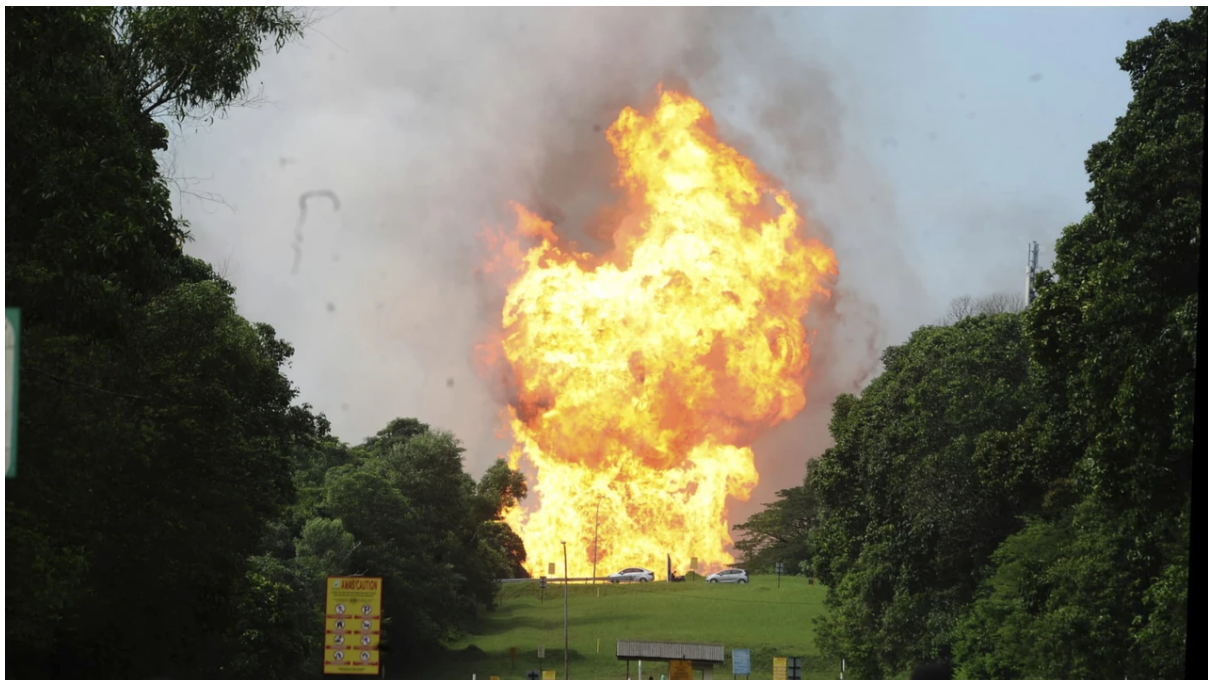
On April 1, 2025, a high-pressure natural gas pipeline exploded in the suburban neighborhood of Putra Heights, Subang Jaya (Selangor, Malaysia), causing one of the country's worst industrial disasters. The 36-inch diameter underground pipeline, operated by Petronas Gas, had been in service since 2000, supplying gas across Peninsular Malaysia. That morning, at approximately 8:08 a.m., residents were jolted by a thunderous blast and a raging fireball in their community. The ensuing inferno, fueled by escaping gas, sent flames soaring over 30 meters high – some eyewitness accounts said hundreds of meters, forming a mushroom-shaped fireball visible from kilometers away. The heat was intense, reportedly reaching up to 1000 °C near the crater, and it ignited homes and vehicles in the vicinity. It took firefighters nearly eight hours to fully extinguish the blaze. Miraculously, no fatalities occurred, but the toll on the community was severe: about 150 people suffered injuries ranging from burns to smoke inhalation. Over 80 houses were completely destroyed and at least 140 more were damaged or rendered unsafe. The explosion carved out a crater approximately 9.8 m deep at the epicenter, and sent debris flying across a wide radius.

Image source: Faihan Ghani / The Star (Malaysia), published in "No foul play in Putra Heights pipeline explosion," July 1, 2025.

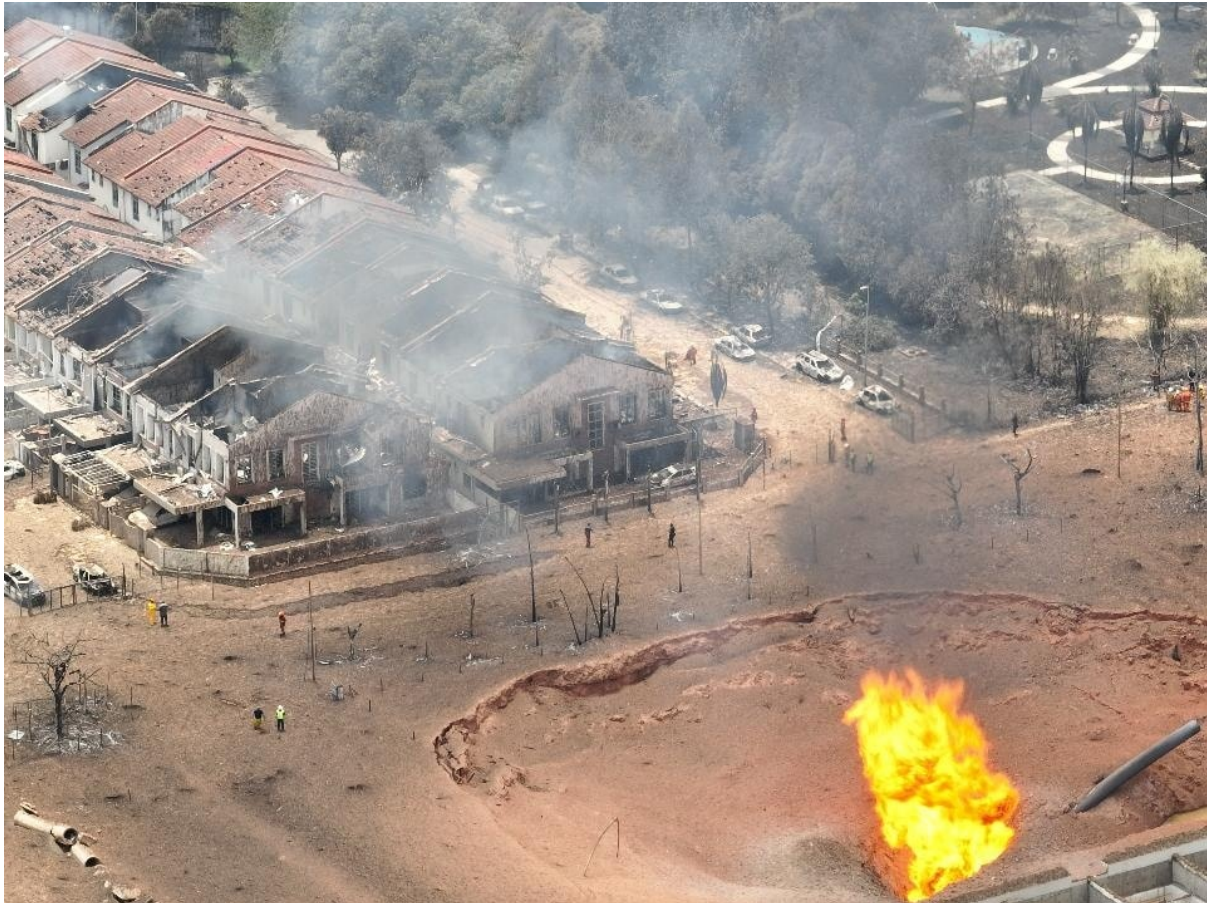
The devastation in the neighborhood was extensive. *Entire rows of terrace houses were reduced to charred shells.* Official tallies indicate 237 houses were affected by the fire, with 88 structures (78 houses and 10 shoplots) burned between 40% to 90% of their build – essentially beyond repair. An estimated 500+ residents had to be evacuated, many of whom lost most of their belongings in the blaze. Over 300 people were displaced into temporary

shelters. The heat melted vehicles; nearly 400 cars and motorbikes were damaged or destroyed in the streets and driveways. Infrastructure was also impacted – power supply tripped in the area and a portion of a nearby highway was closed as a precaution until the site was secured. Cracks and soot marks extended hundreds of meters from the explosion center.

Image source: Bernama / New Straits Times, April 2, 2025.

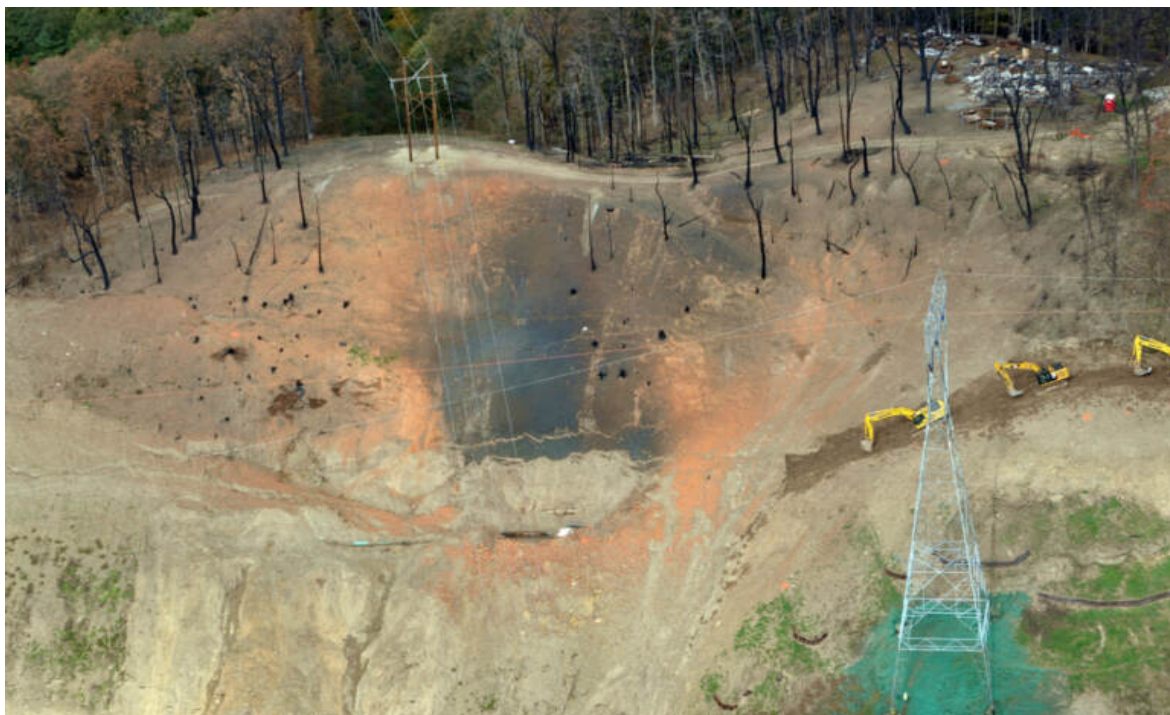
In September 2018, heavy rainfall in western Pennsylvania caused a landslide that ruptured the 24-inch Revolution natural gas pipeline shortly after it began operation. The sudden rupture released a massive volume of gas which ignited explosively, leveling a nearby house, toppling several high-voltage transmission towers, and scorching several acres of woodland. The pipeline (about 65 km long) was a newly built transmission line carrying Marcellus Shale gas and was in the process of being commissioned at the time of the incident. Fortunately, no injuries were reported (the residents of the house had evacuated), but the destruction underscored the devastating potential of geohazard-induced failures in steep terrain.

Image source: Pennsylvania PUC / NTSB investigation of Revolution Pipeline Explosion (Beaver County, USA), 2018.

Investigators determined that the pipeline route traversed an unstable slope where improper erosion control and backfill compaction during construction left it vulnerable to movement. Intense rainfall triggered ground subsidence and slippage on the steep hillside, causing the buried pipeline to bend and separate at a girth weld. The released gas found an ignition source, resulting in a girth-weld rupture and fireball. Regulatory authorities cited the operator (Energy Transfer) for inadequate geotechnical risk management. The company was fined and agreed to a settlement of about \$2 million that included civil penalties and requirements for enhanced slope stabilization and monitoring measures. The pipeline remained shut down until the operator implemented corrective actions, such as improved drainage, hillside reinforcement, and revised start-up procedures, to prevent similar failures in the future. This case highlighted the need for rigorous geotechnical surveys and landslide mitigation in pipeline design and routing in Appalachian terrain.
