ART CRAWLER SERVICES

**NON-INVASIVE CORROSION
INSPECTION SERVICE**

Make Inspections a Work of ART

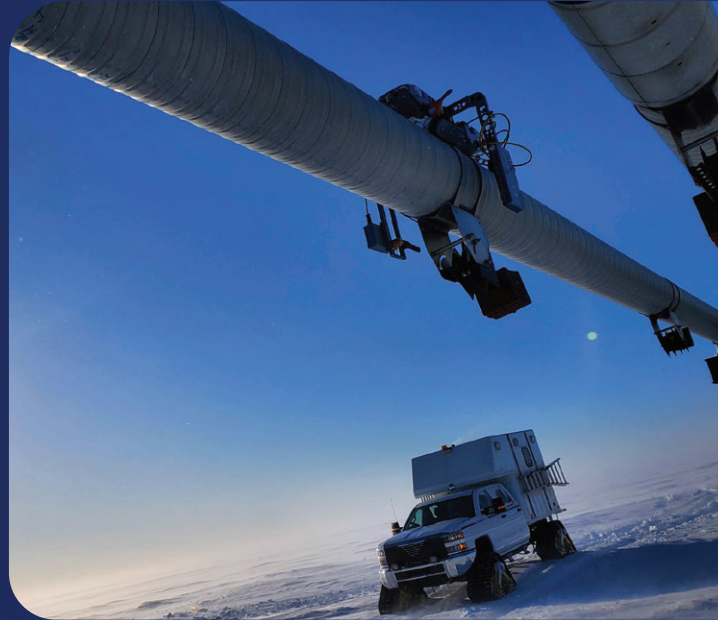
INTERNAL CORROSION CRAWLER SERVICES	
TECHNIQUE	Thru-Wall Radiography
PIPE RANGE (INSULATED)	4" - 48" overall OD in-service lines
PHYSICAL SPECS	55" x 11" x 10"; 70 lbs.
REGION OF INTEREST	Bottom quadrant of pipe
DAMAGE MECHANISMS	General corrosion, isolated pitting, MIC, pipe liner failure, plugging
WIRELESS RANGE	Up to ½ mile line of sight
POWER REQUIREMENTS	56v Li-ion battery
CLIMB ANGLE	0-15 degrees from horizontal
TEMPERATURE RANGE	-40 F to 120 F
IMAGERS	Multi-line Photon Detectors
X-RAY ENERGY	60kV to 225kV

CUI CRAWLER SERVICES	
TECHNIQUE	Tangential OD Radiography
PIPE RANGE (INSULATED)	2" to 48" overall OD in-service lines
PHYSICAL SPECS	36" x 8" x 8"; 37 lbs.
REGION OF INTEREST	Single & multi azimuth
DAMAGE MECHANISMS	CUI, moisture saturation, insulation failure, ice build-up, weld ID
WIRELESS RANGE	Up to ½ mile line of sight
POWER REQUIREMENTS	56v Li-ion battery
CLIMB ANGLE	0-15 degrees from horizontal
TEMPERATURE RANGE	-40 F to 120 F
IMAGERS	Multi-line Photon Detectors
X-RAY ENERGY	50kV to 160kV

360° CRAWLER SERVICES	
TECHNIQUE	Tangential OD Radiography
PIPE RANGE (INSULATED)	12" to 60" overall OD in-service lines
PHYSICAL SPECS	70lbs + ring weight (varies by diameter)
REGION OF INTEREST	360 degrees OD
DAMAGE MECHANISMS	CUI, Moisture saturation insulation failure, ice build-up, weld ID
POWER REQUIREMENTS	110 VAC
CLIMB ANGLE	0-15 degrees from horizontal; ≥3D 90-degree elbows
TEMPERATURE RANGE	-40 F to 120 F
IMAGERS	Large Area CMOS detector
X-RAY ENERGY	50kV to 225kV

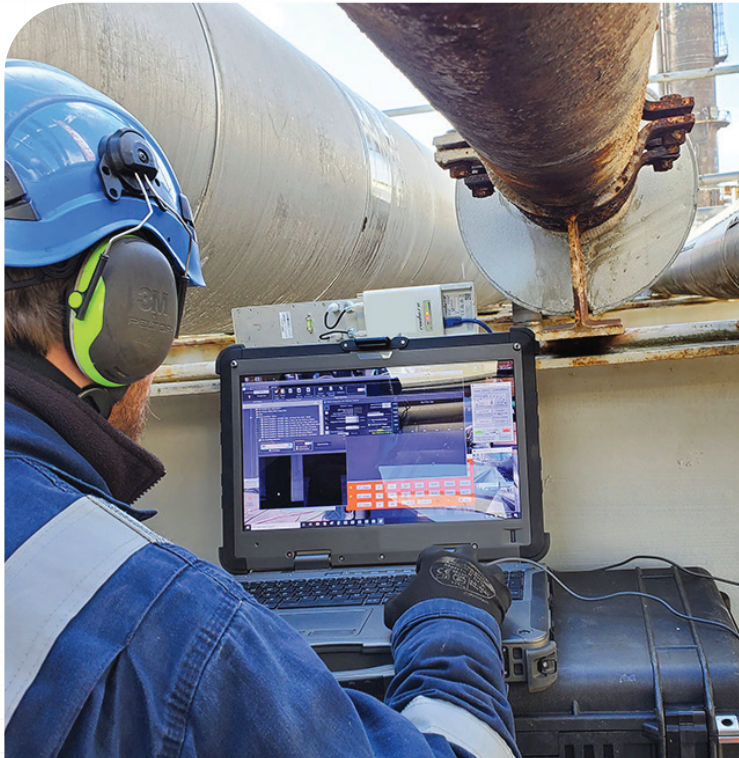
A CLOSER LOOK

The crawler provides quick and advanced radiographic data results that produce high-resolution, DICOM-compliant images.

The fully wireless crawler's two-axis robotic arm and slim body allow it to effortlessly traverse past supports and other obstacles.

With options for pipelines from 2-60 inches, the ART Crawler is compatible with any aboveground, horizontal pipeline, including those with product still in them.

4-view screening capability enables CUI and wet or damaged insulation to be viewed at the top, bottom, and sides of the pipe.

Tested in harsh weather conditions, the crawler can operate in subprime environments, eliminating the need to postpone or reschedule work.
